Biodegrading and Bio deteriorating monuments of Ujjain: a comparison of the current status to Simhasth 2016 of Ujjain, MP, India

Vanshree Pandya* and Sudhir Kumar Jain

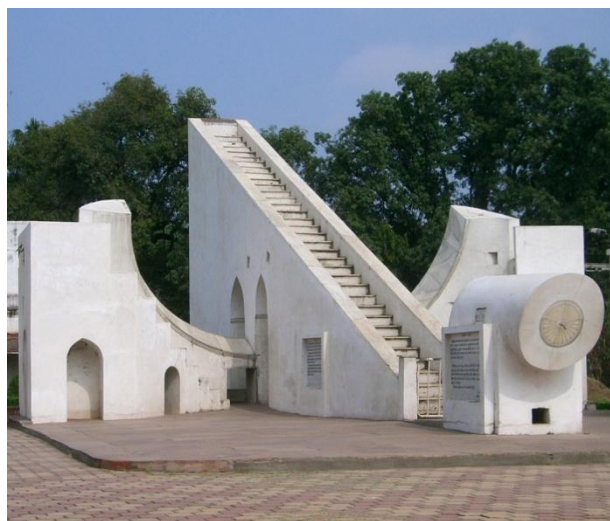
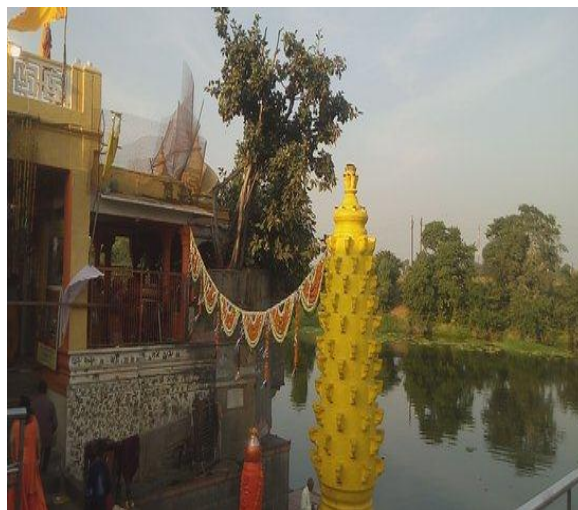
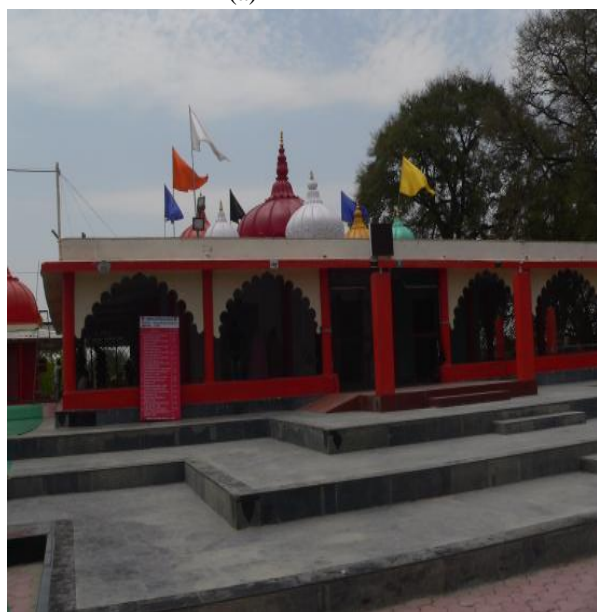
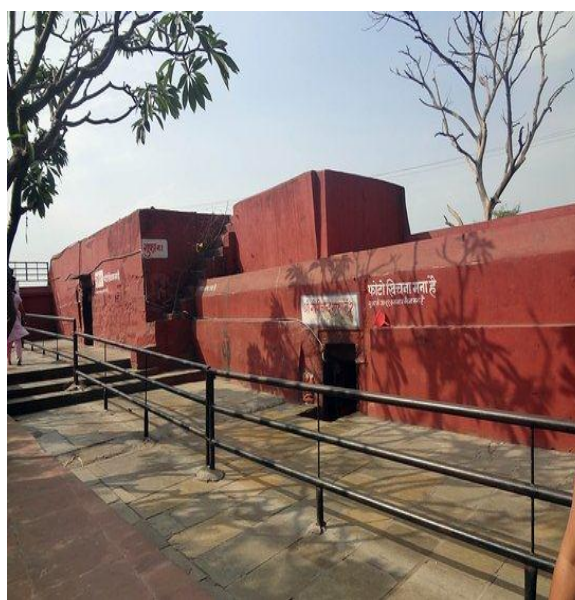
Figure-1: Photographs taken from: A. Jantar Mantar Ved shala Ujjain. B. Gopichand Gufa Bharthari Caves Ujjain. C. Shani Mandir Ujjain D. Siddhawat Ujjain¹³.

was observed that negligence was one of the major causes of such depreciating condition, which can be prevented through regular maintenance. As a result of his study it was observed that the condition of the monuments were comparatively way better during the time of Simhasth 2016. The surface was found clean because of the refurbishment that included cleaning and

painting. And there was no such deterioration and degradation found. This can be seen in Figure-1. As the condition started to deteriorate over time, in 2018 the area were a bit cleaner than current time (around 25%). Most of the area was covered with microbial growth (Figure-2). The highly affected areas showed a mean value of 28% which was mainly because of fungal growth and plants. The amount of biodegradation and deterioration during current time was very high (Contingency Chi-Squared Test = 8.65, $p < 0.005$).

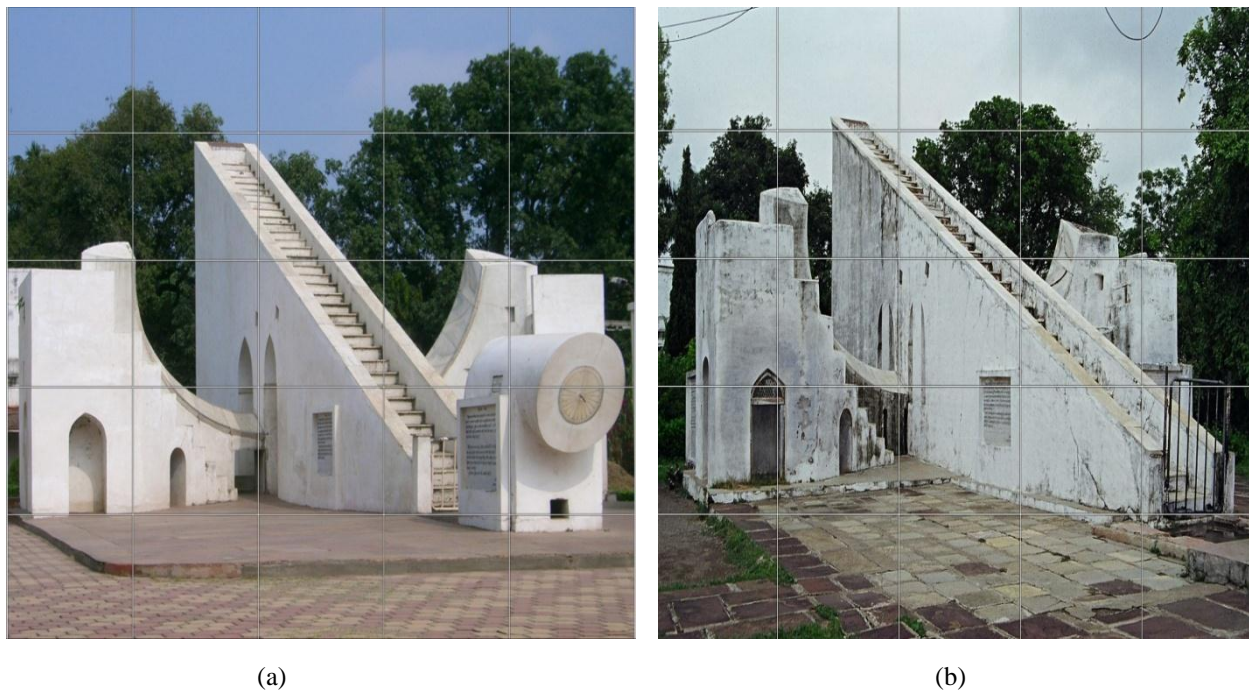
On each image we overlaid a grid (45.5 cells per image). This technique is commonly used in Lichen studies. Then comparisons of the expected values with the observed values from the variations on the chi-square statistic was calculated from the following form.

On each photograph and for each section of the grid we set the description as i. Surface area of monument without any visible degradation and the degrading agents. ii. Surface area of monument on which microbial growth present. iii. Surface area of monument on which degradation due to microbial growth is highly present.

Figure-3: Sample of grid used to determine the biodegradation caused by microbes in the photographs.

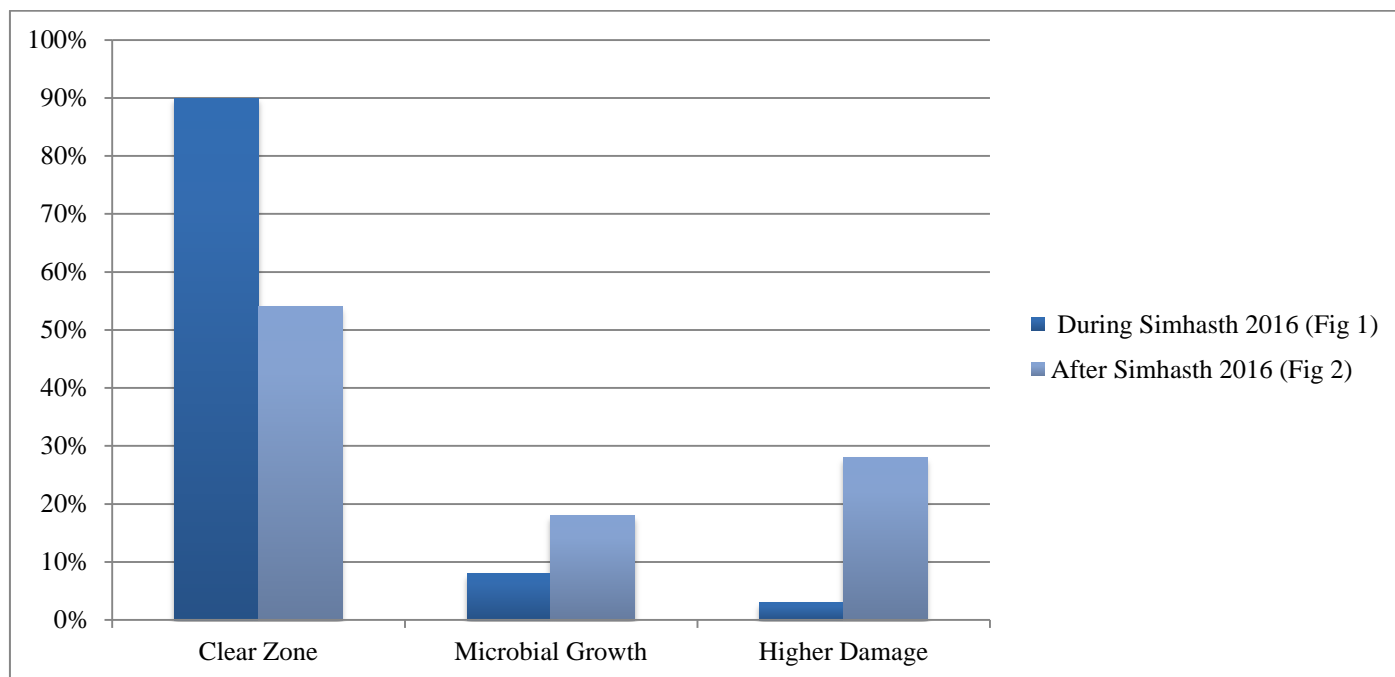
The data thus collected, evaluated the total sections of grids with each condition for the statistical test. After that we computed the mean values shown in Figure-4.

Figure-4: Calculation of mean percentage showing the surface area of monuments with clear zones, area covered with microbial growth and area showing higher damage.
