Important aspects of Inter turn Insulation in High Voltage Motors

Puranik K.K.

Singhania University, Pachheri Bari, Rajasthan, INDIA

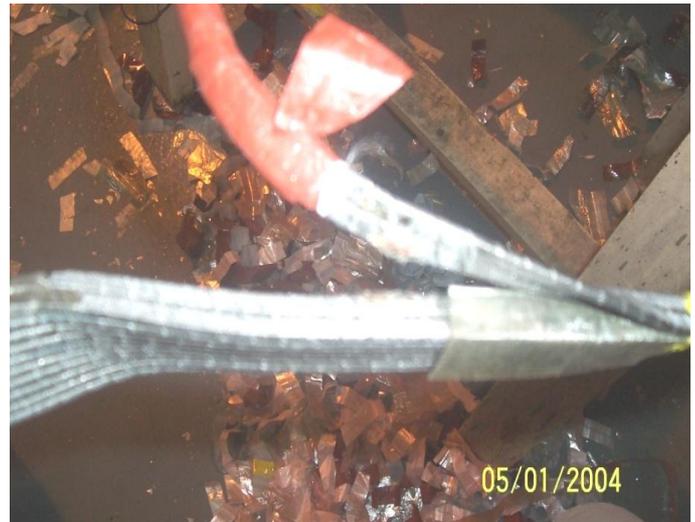
Figure-2

Damage of lead turn insulation resulted in inter turn insulation

Main insulation of the coil was removed on connection end side over hang portion. On opening the insulation the failure point was observed between top coil side connection lead and adjacent turn. As per drawing an additional reinforcement⁸ is provided to protect the turn below lead to sustain mechanical pressure exerted on lead during winding and connection of series joint. It was observed that the protection piece of resin poor mica paper tape⁸ having glass baking on both sides, was found damaged. Due to damage of this protection piece the pressure created during winding has damaged the turn insulation resulting in turn to turn short.
